LIGHTWEIGHT GEARBOX COMPOSITE CASE.
PHASE II.

**PHASE II
LIGHTWEIGHT GEARBOX
COMPOSITE CASE**

**FINAL REPORT
(18 MARCH 1970 TO 18 JANUARY 1971)**

**Detroit Diesel Allison Division • General Motors
Indianapolis, Indiana**

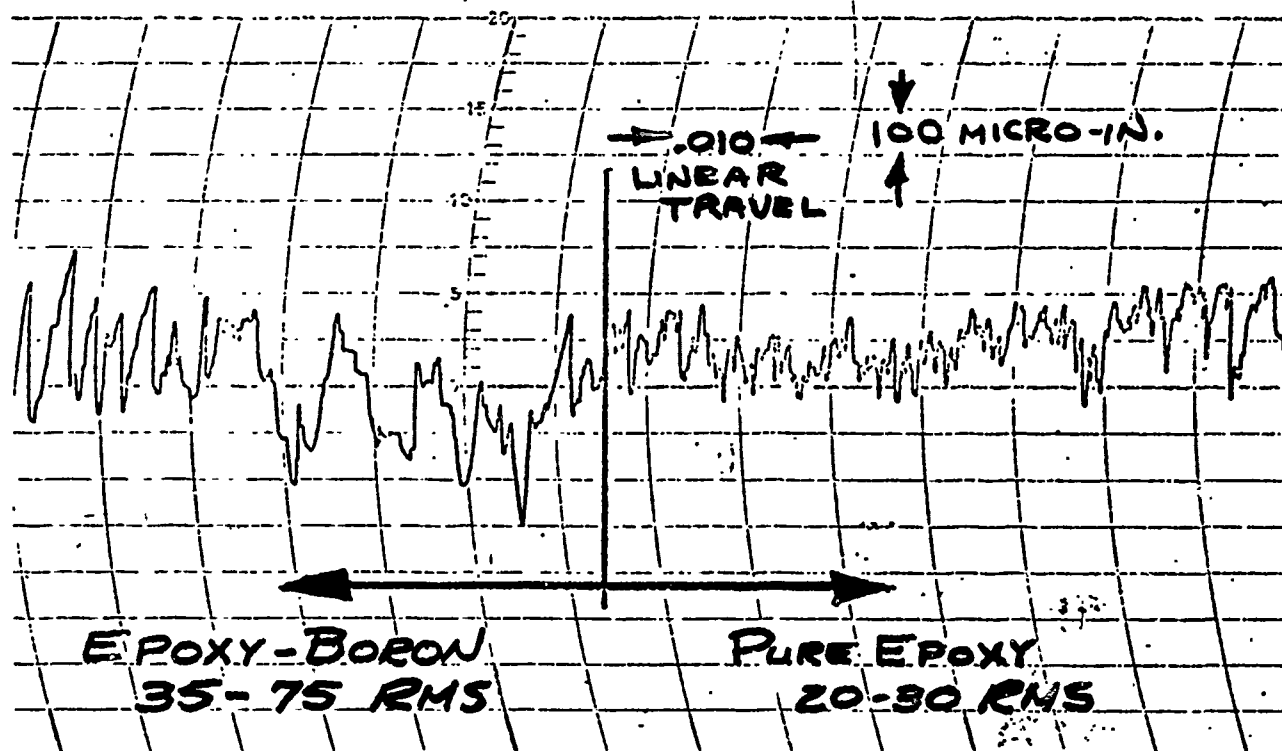
Proficorder Trace of Pure Epoxy and
Boron-Epoxy Surface Finish

Some specific areas required a 32 RMS or better finish for "O" ring seals. These areas were machined to allow for a .002 per side coating of a Dow Epoxy Novalac 438-Nadic Methyl Anhydride cured resin system. This resulted in a 20-30 RMS finish on the pure epoxy after regrind, and was acceptable from a design standpoint. Figure 8 is a Proficorder peak-to-valley trace of both a boron-epoxy and pure epoxy surface.

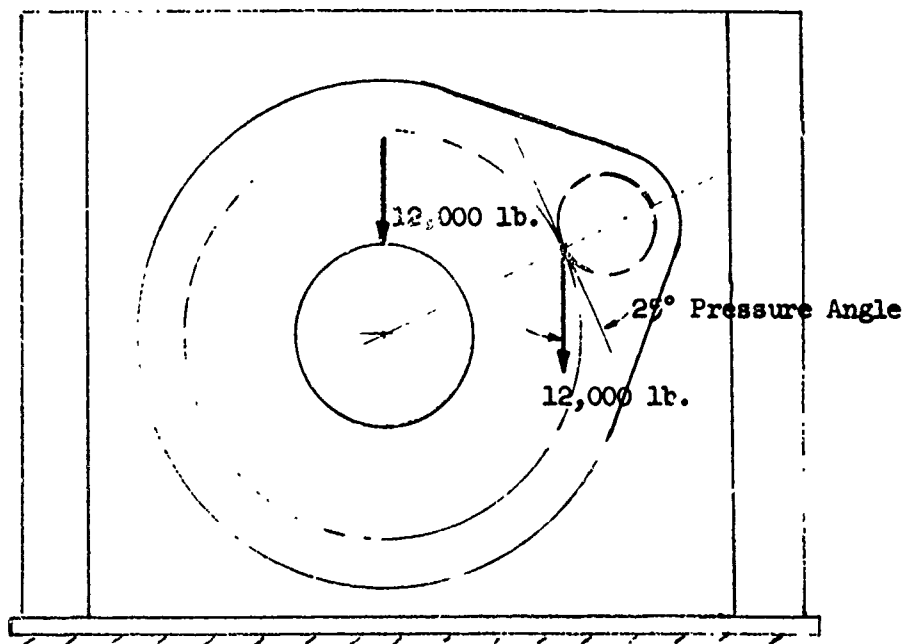
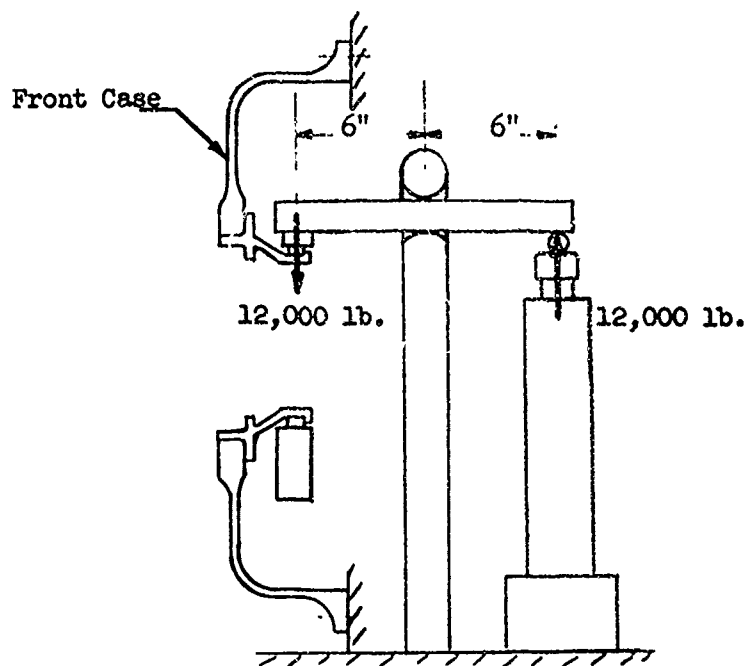
Figure 9 - Static Deflection Test Set-Up

The case was mounted to a steel plate which was supported by ram stands. A hydraulic ram supplied the force from outside the case by means of a fulcrum bar loading into a steel ring. The load was transferred from the ring through the bearing rollers to the bearing support. Figure 9 shows a sketch of the test set-up. A photograph of the loading method is shown in Figure 10.

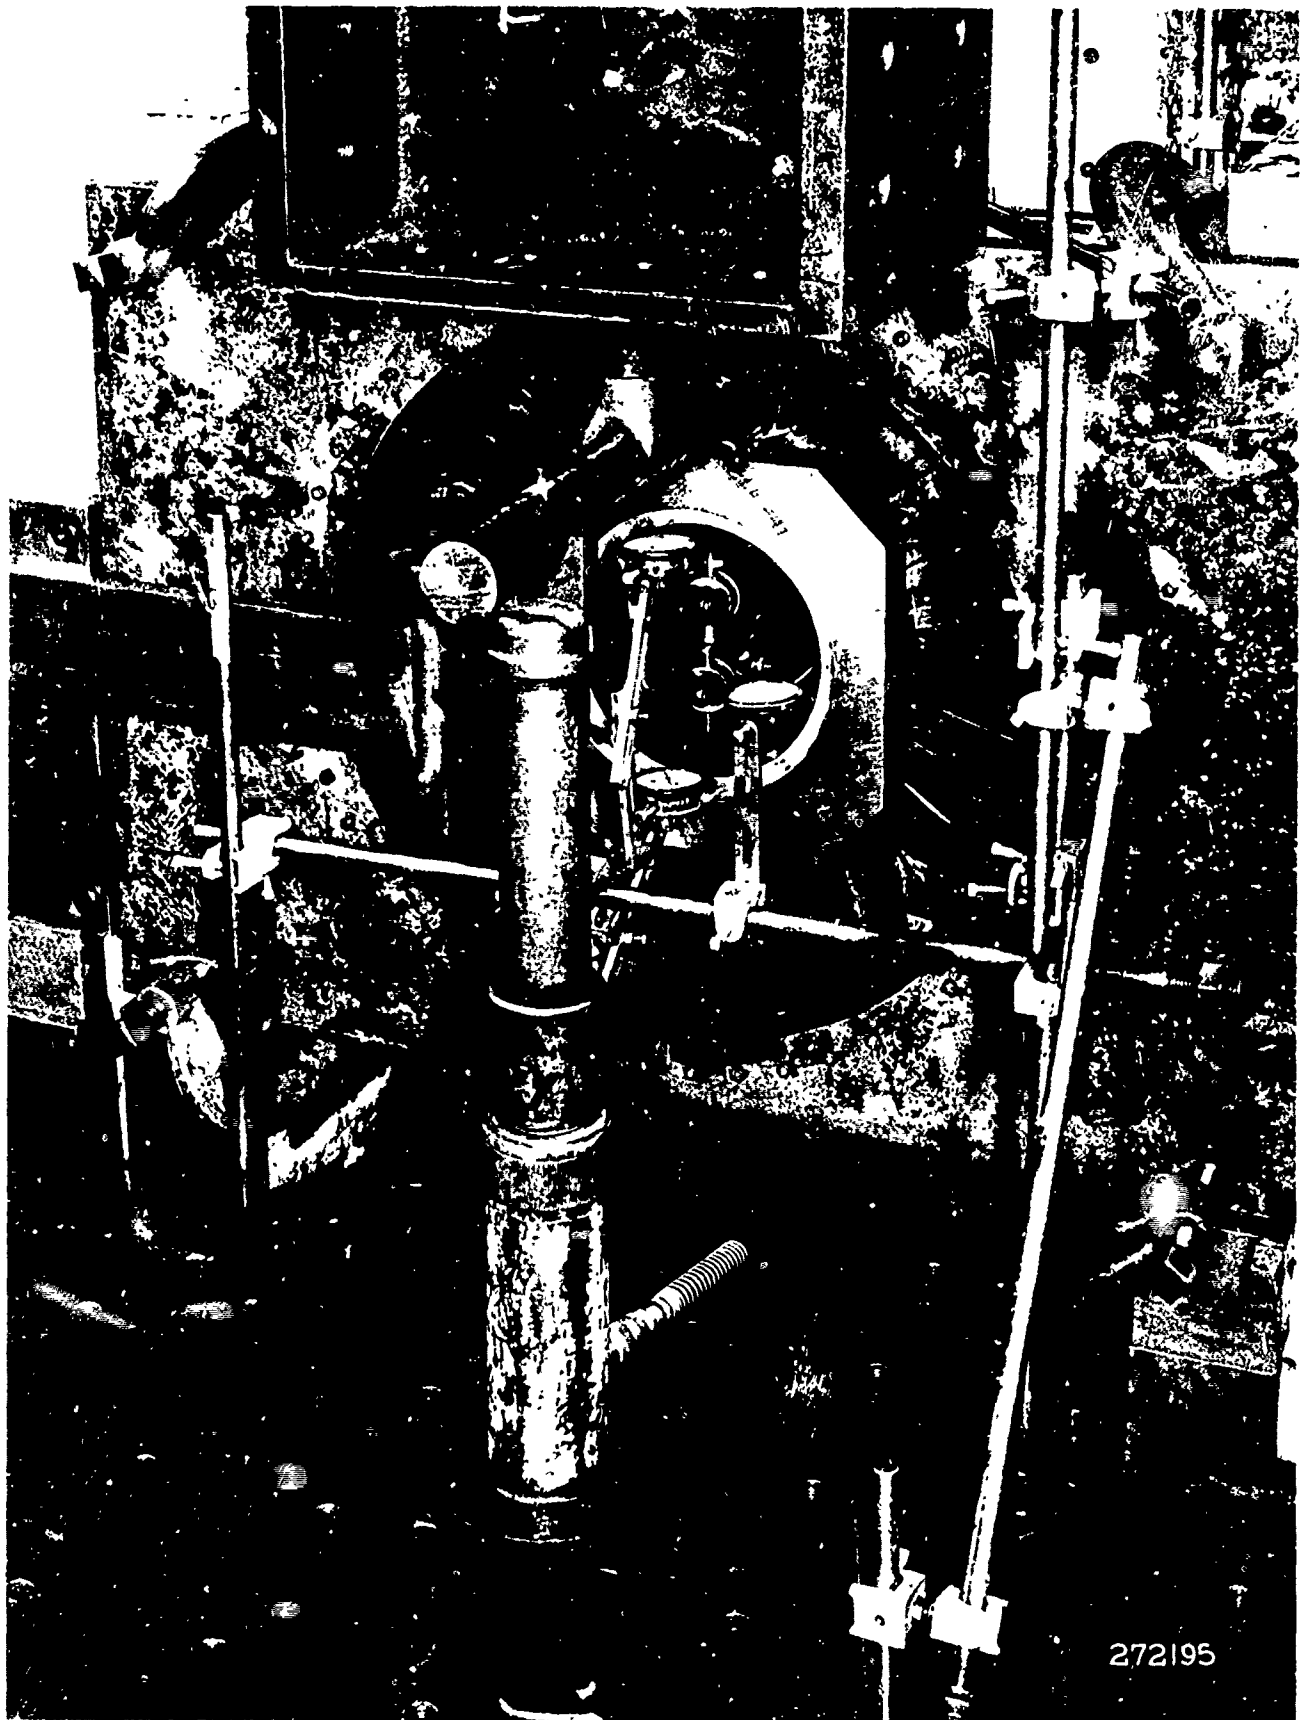
FIGURE 10 STATIC DEFLECTION TEST LOADING

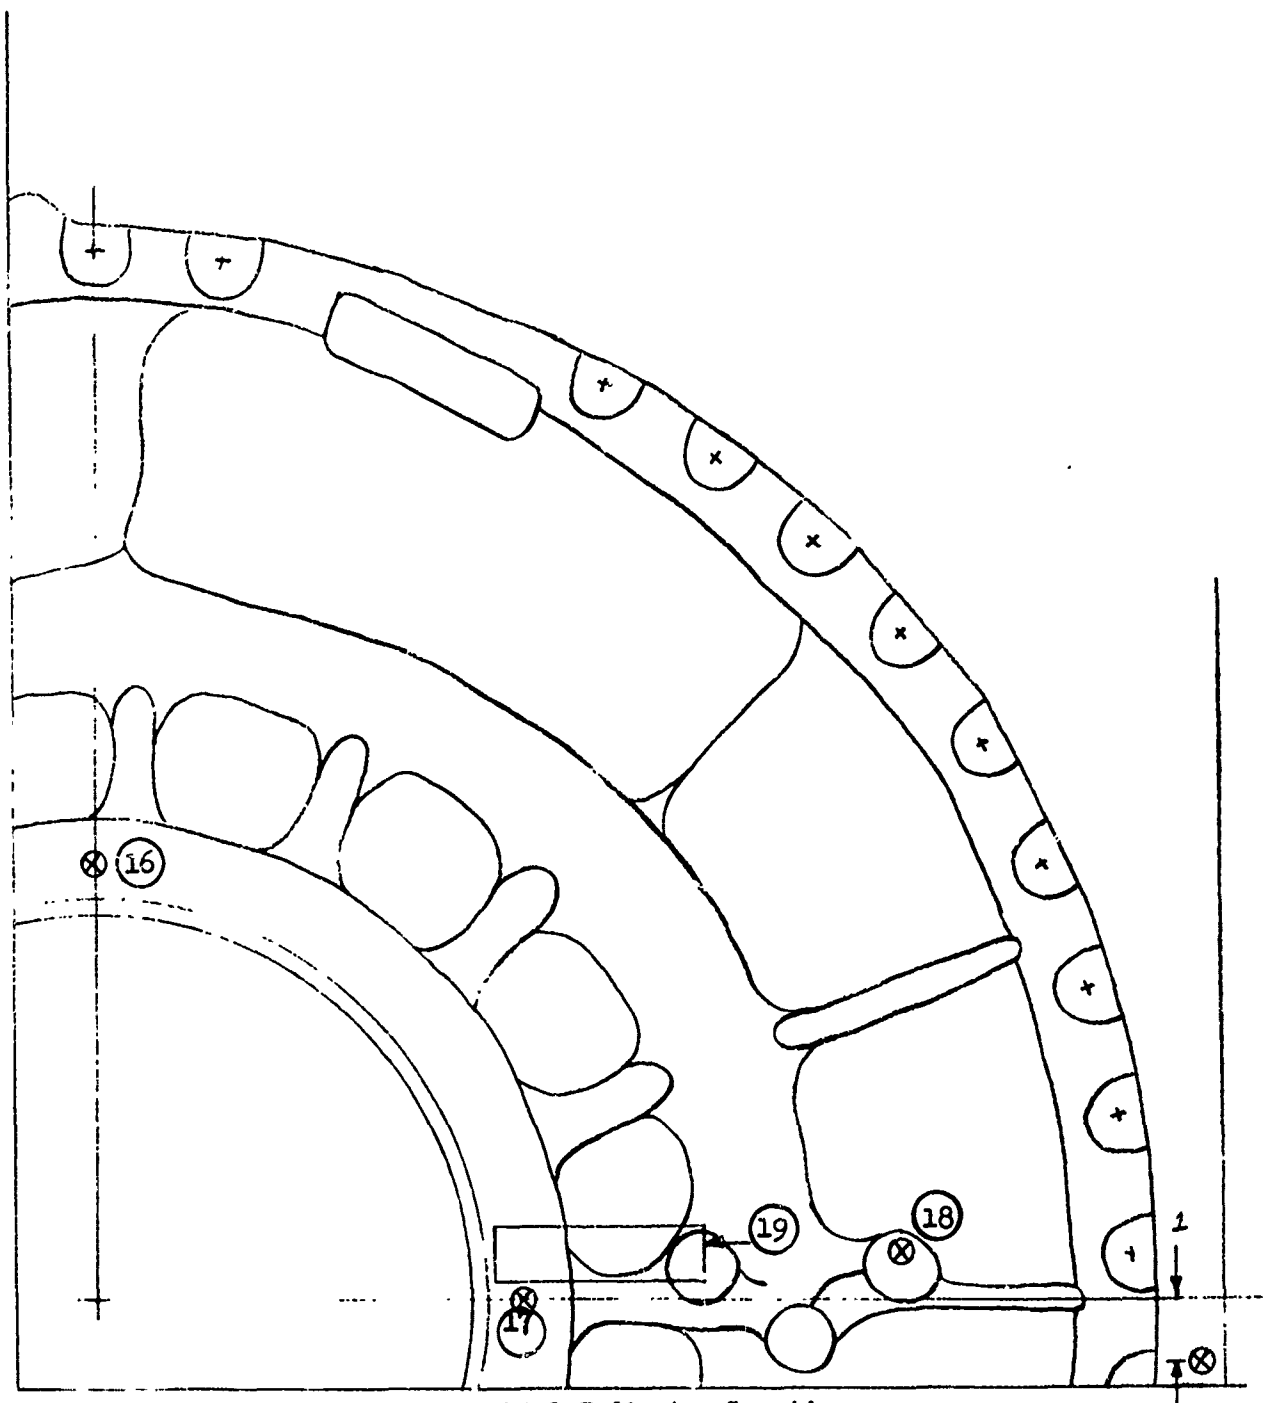
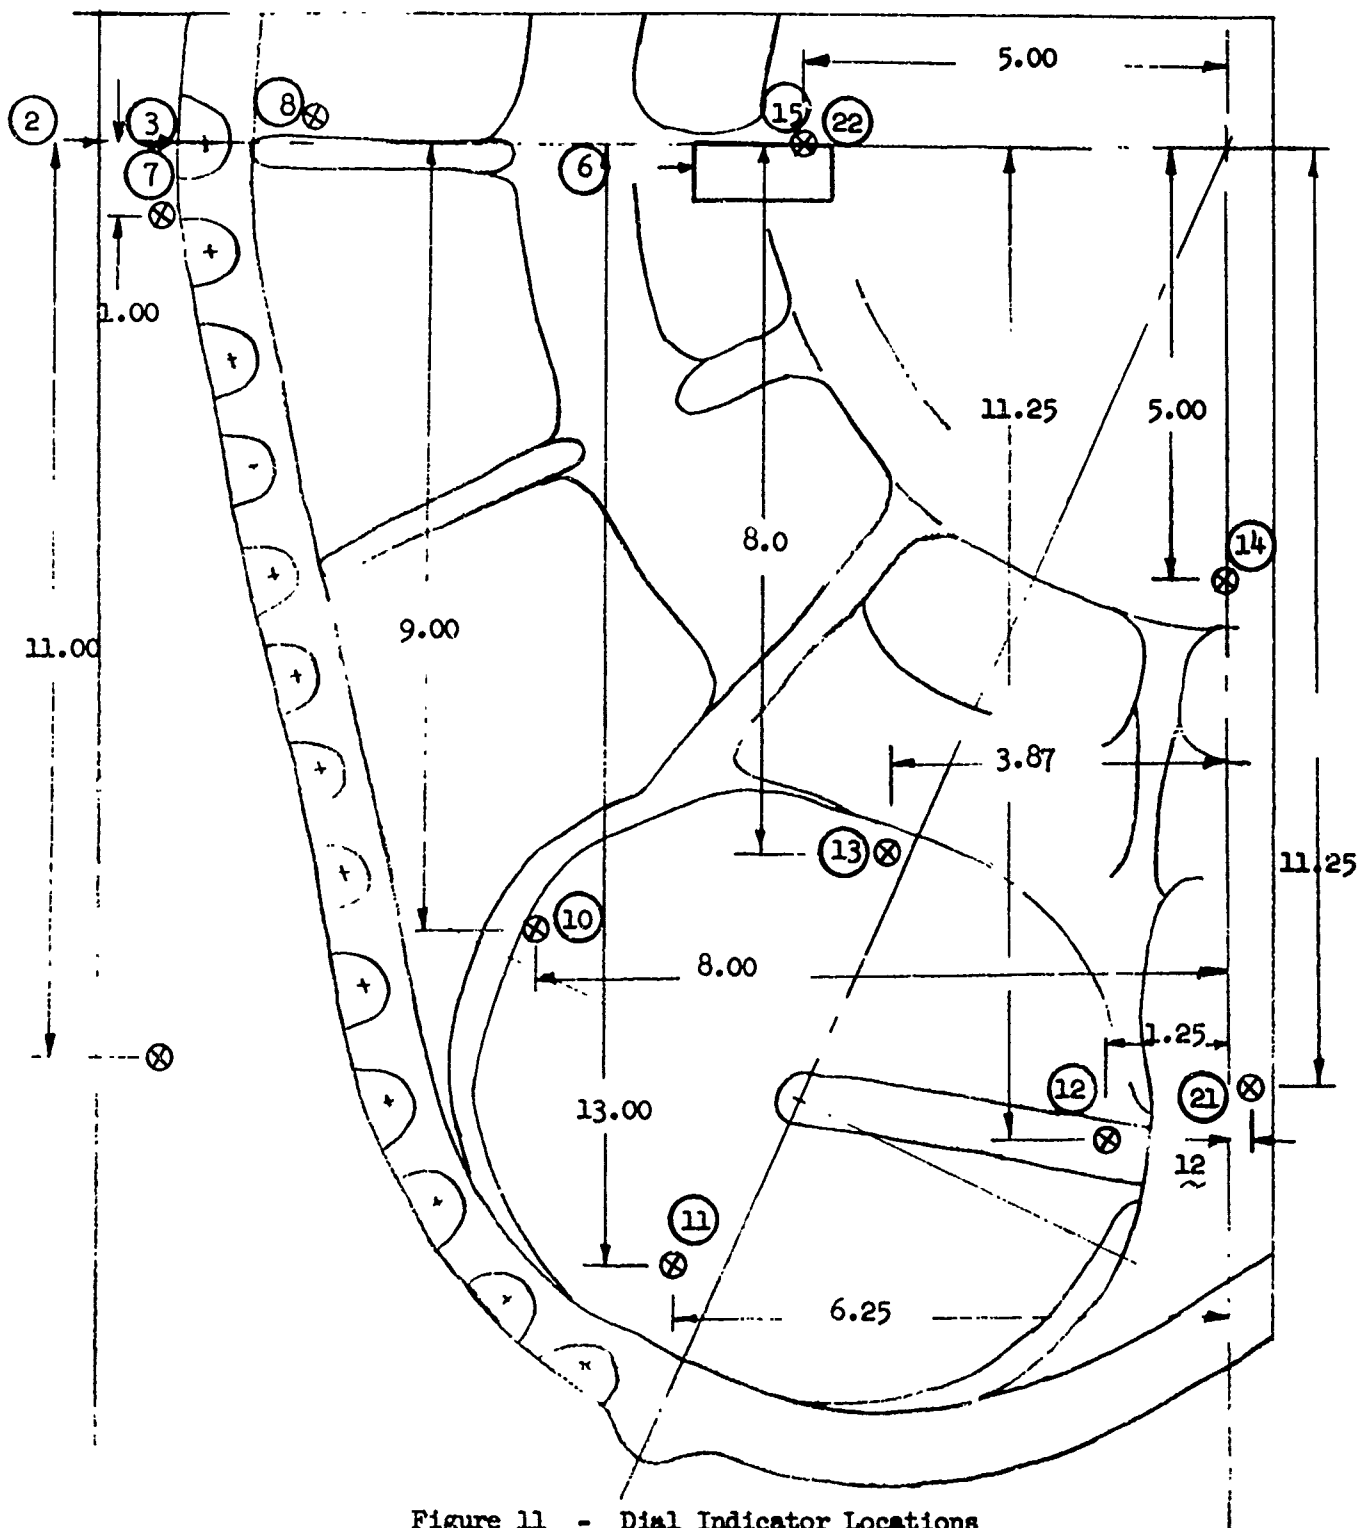
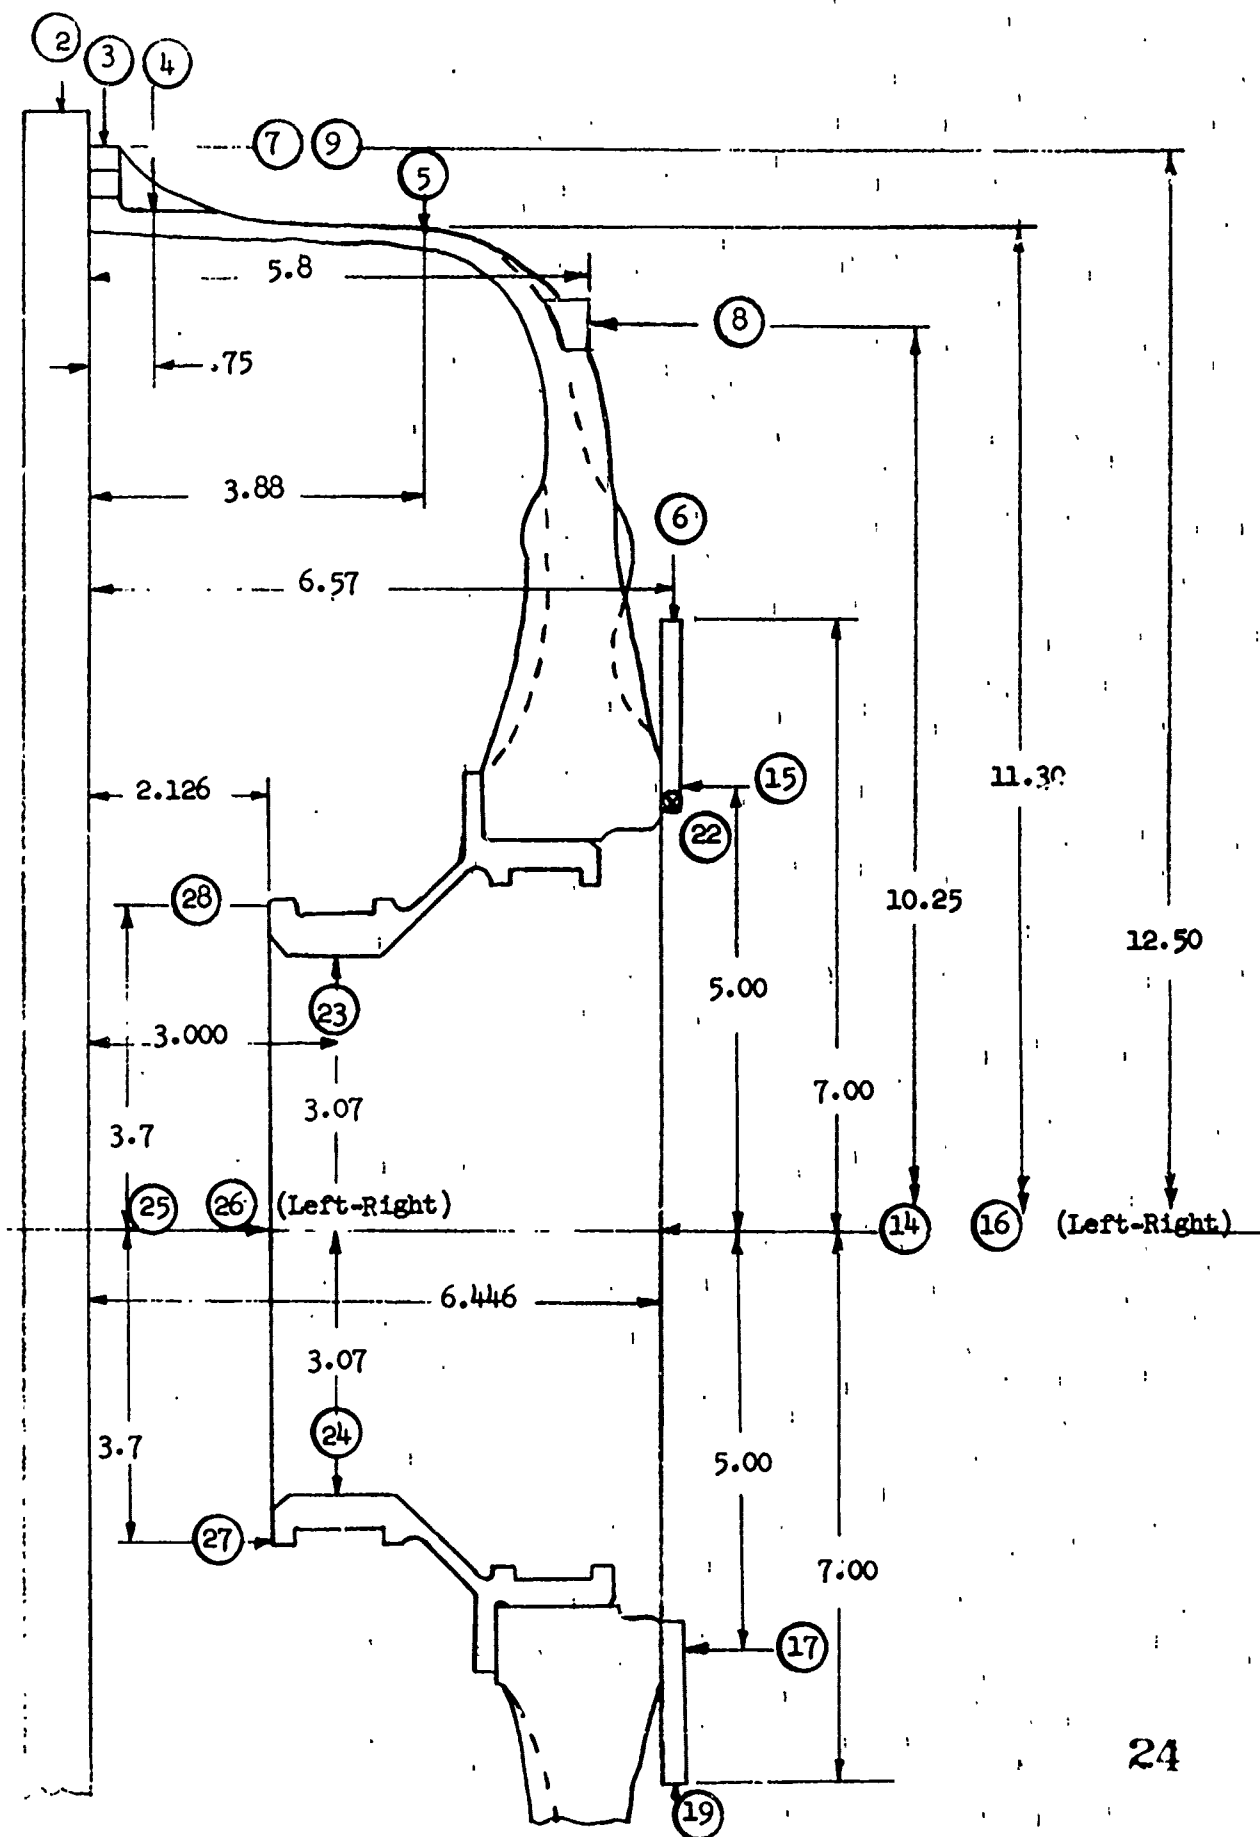
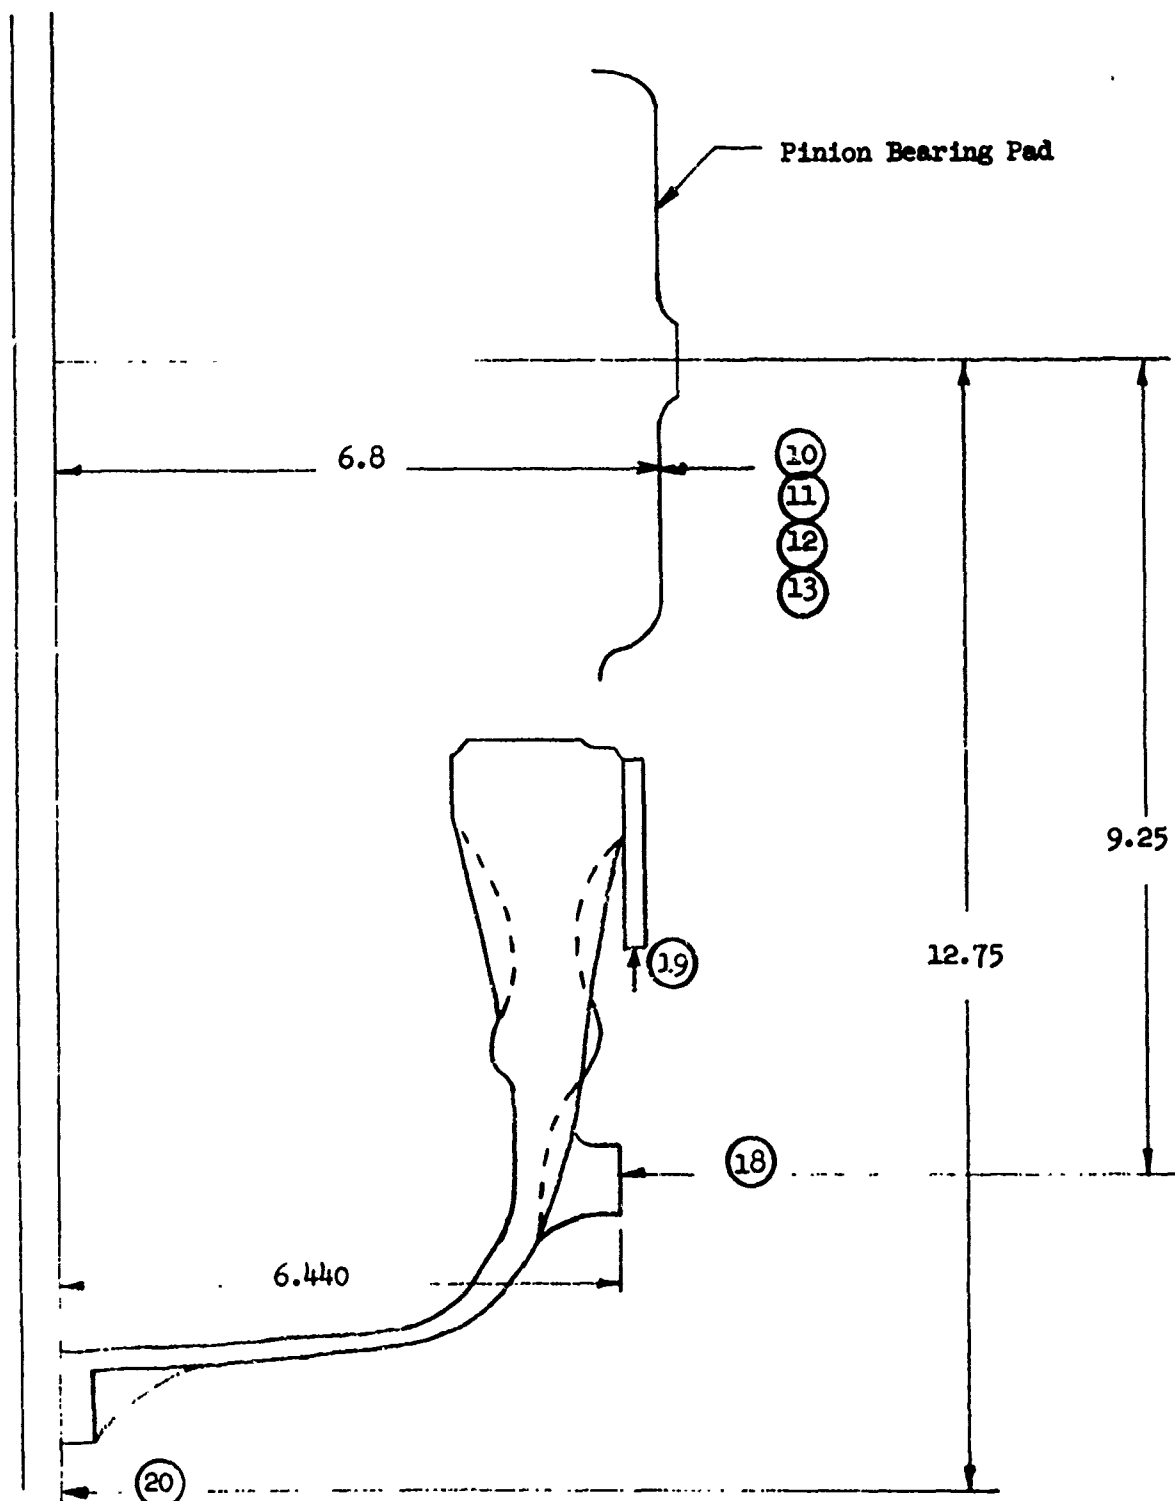
Figure 11 - Dial Indicator Locations

Dial indicators were installed to obtain front face deflection at the center bore, front face deflection at the pinion bearing pad, main drive gear bearing support deflections and other deflections on the outside of the case. The locations of the indicators are shown in Figure 11. A photograph of the instrumentation is presented in Figure 12.

* This slope measured by indicators #10 & 12 (Figure 11)

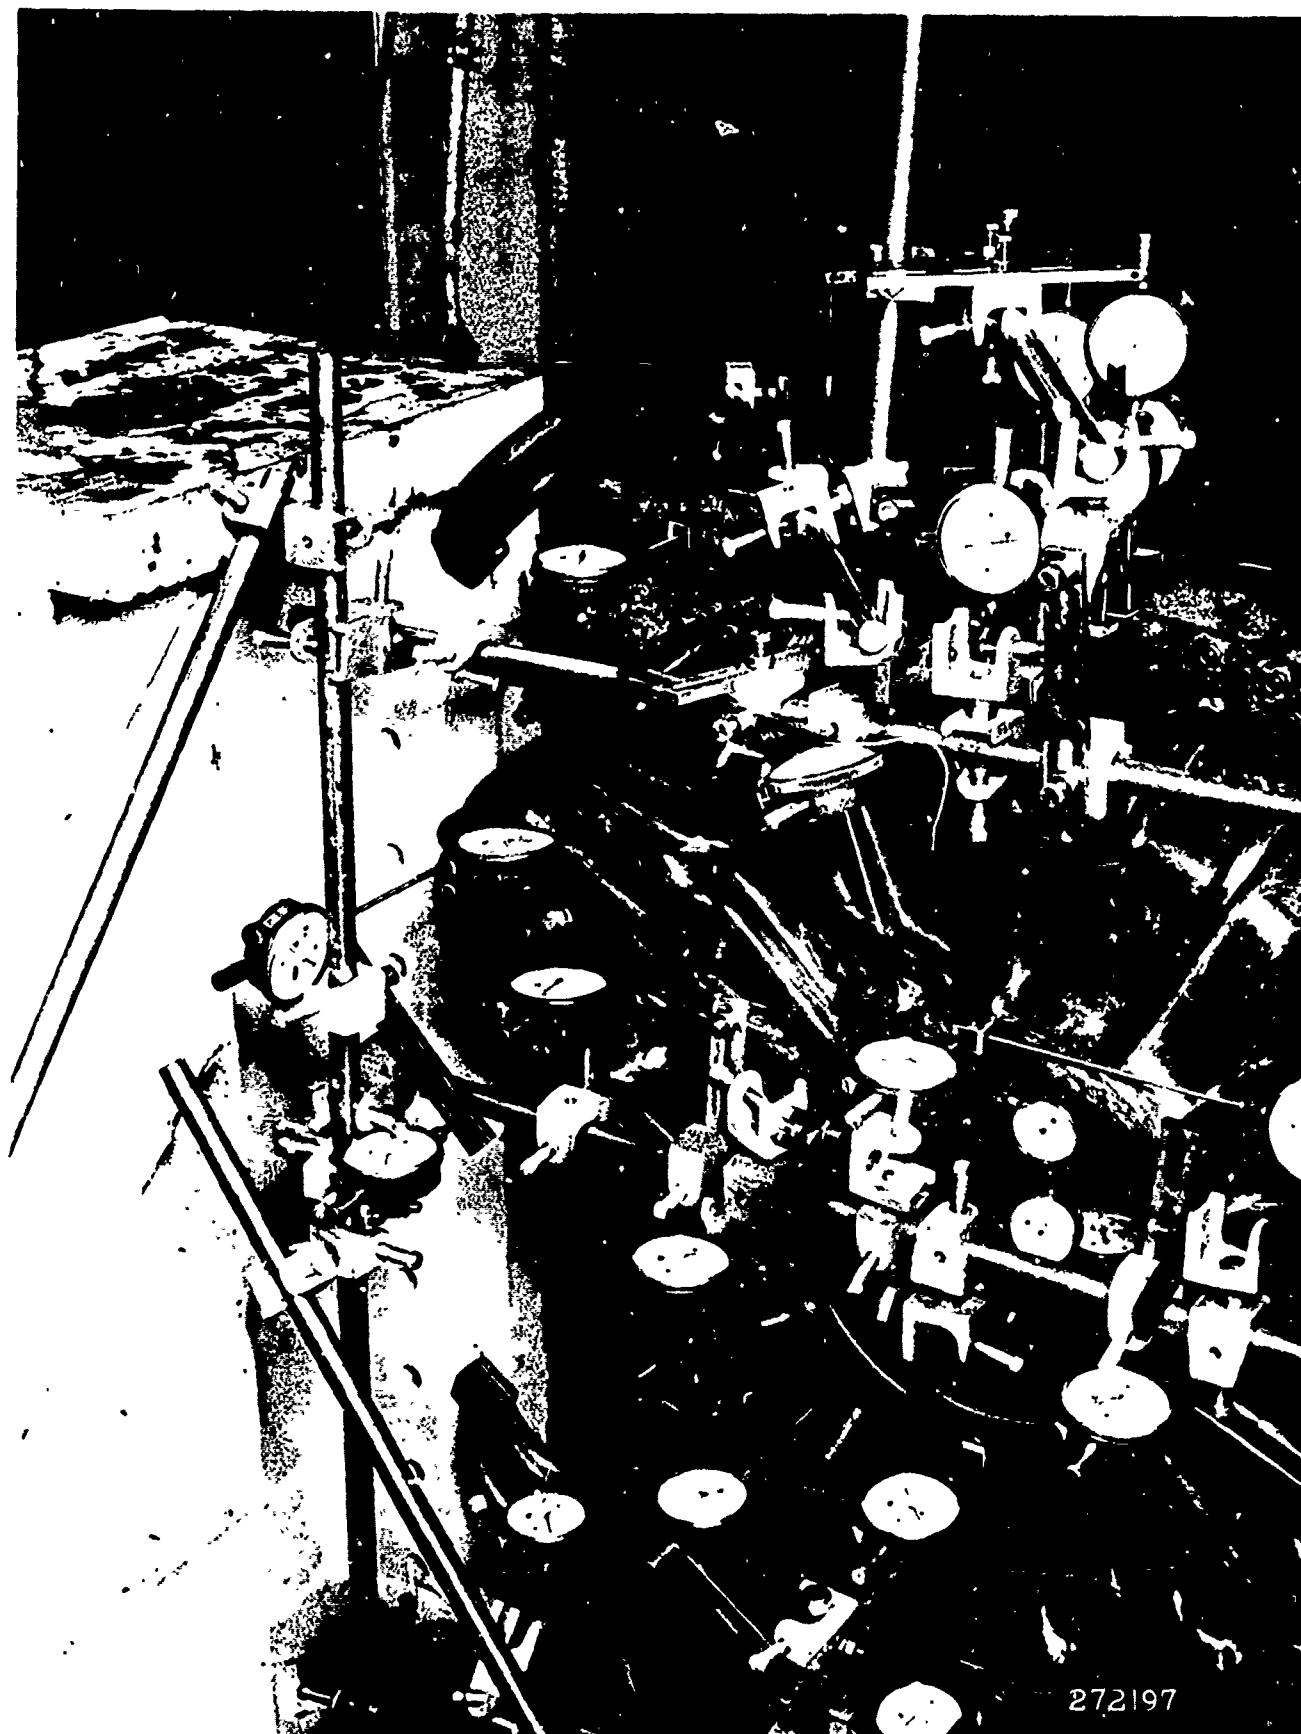
FIGURE 12 STATIC DEFLECTION TEST INSTRUMENTATION

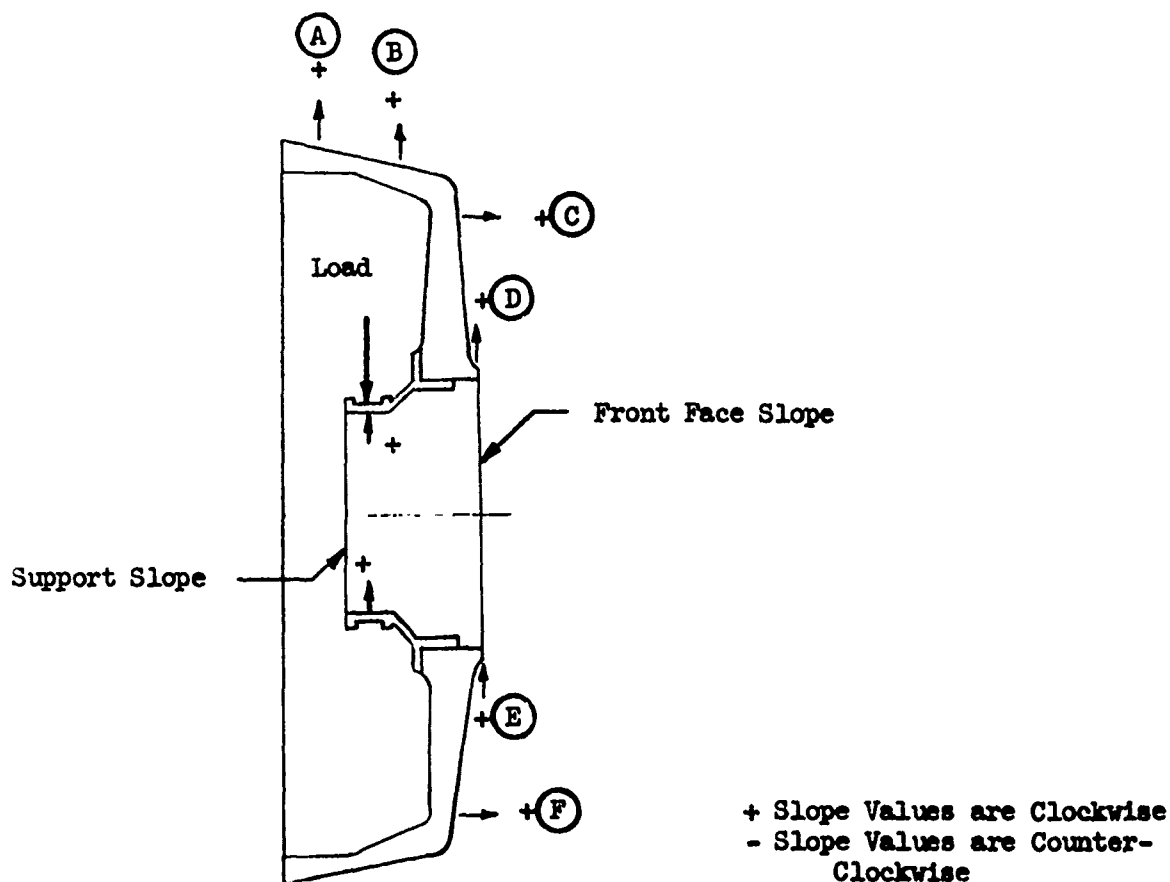
Figure 13 - Static Deflection Test Results

Deflection Item	Magnesium Case	Boron-Epoxy Case
Front Face Slope (in/in)	-.00212	-.00179
Support Slope (in/in)	-.00221	-.00197
Pinion Face Slope (in/in)*	-.00003	-.00042
Support Radial Def. (Top)	-.0196	-.0145
Support Radial Def. (Bottom)	-.0116	-.0085
Point A	-.0009	+.0005
Point B	+.0008	-.0051
Point C	-.0055	+.0028
Point D	-.0088	-.0076
Point E	-.0078	-.0058
Point F	+.0064	+.0092

The test results on boron-epoxy case are given along with data previously obtained on the magnesium case in Figure 13. These values have been corrected for any deflection of the steel mounting plate. The composite case showed less slope change than the magnesium case; 16% less at the front face and 11% less at the support. The composite case also showed less radial translation of the main bore than the magnesium case; 26% less at the support and 14% less at the front face.

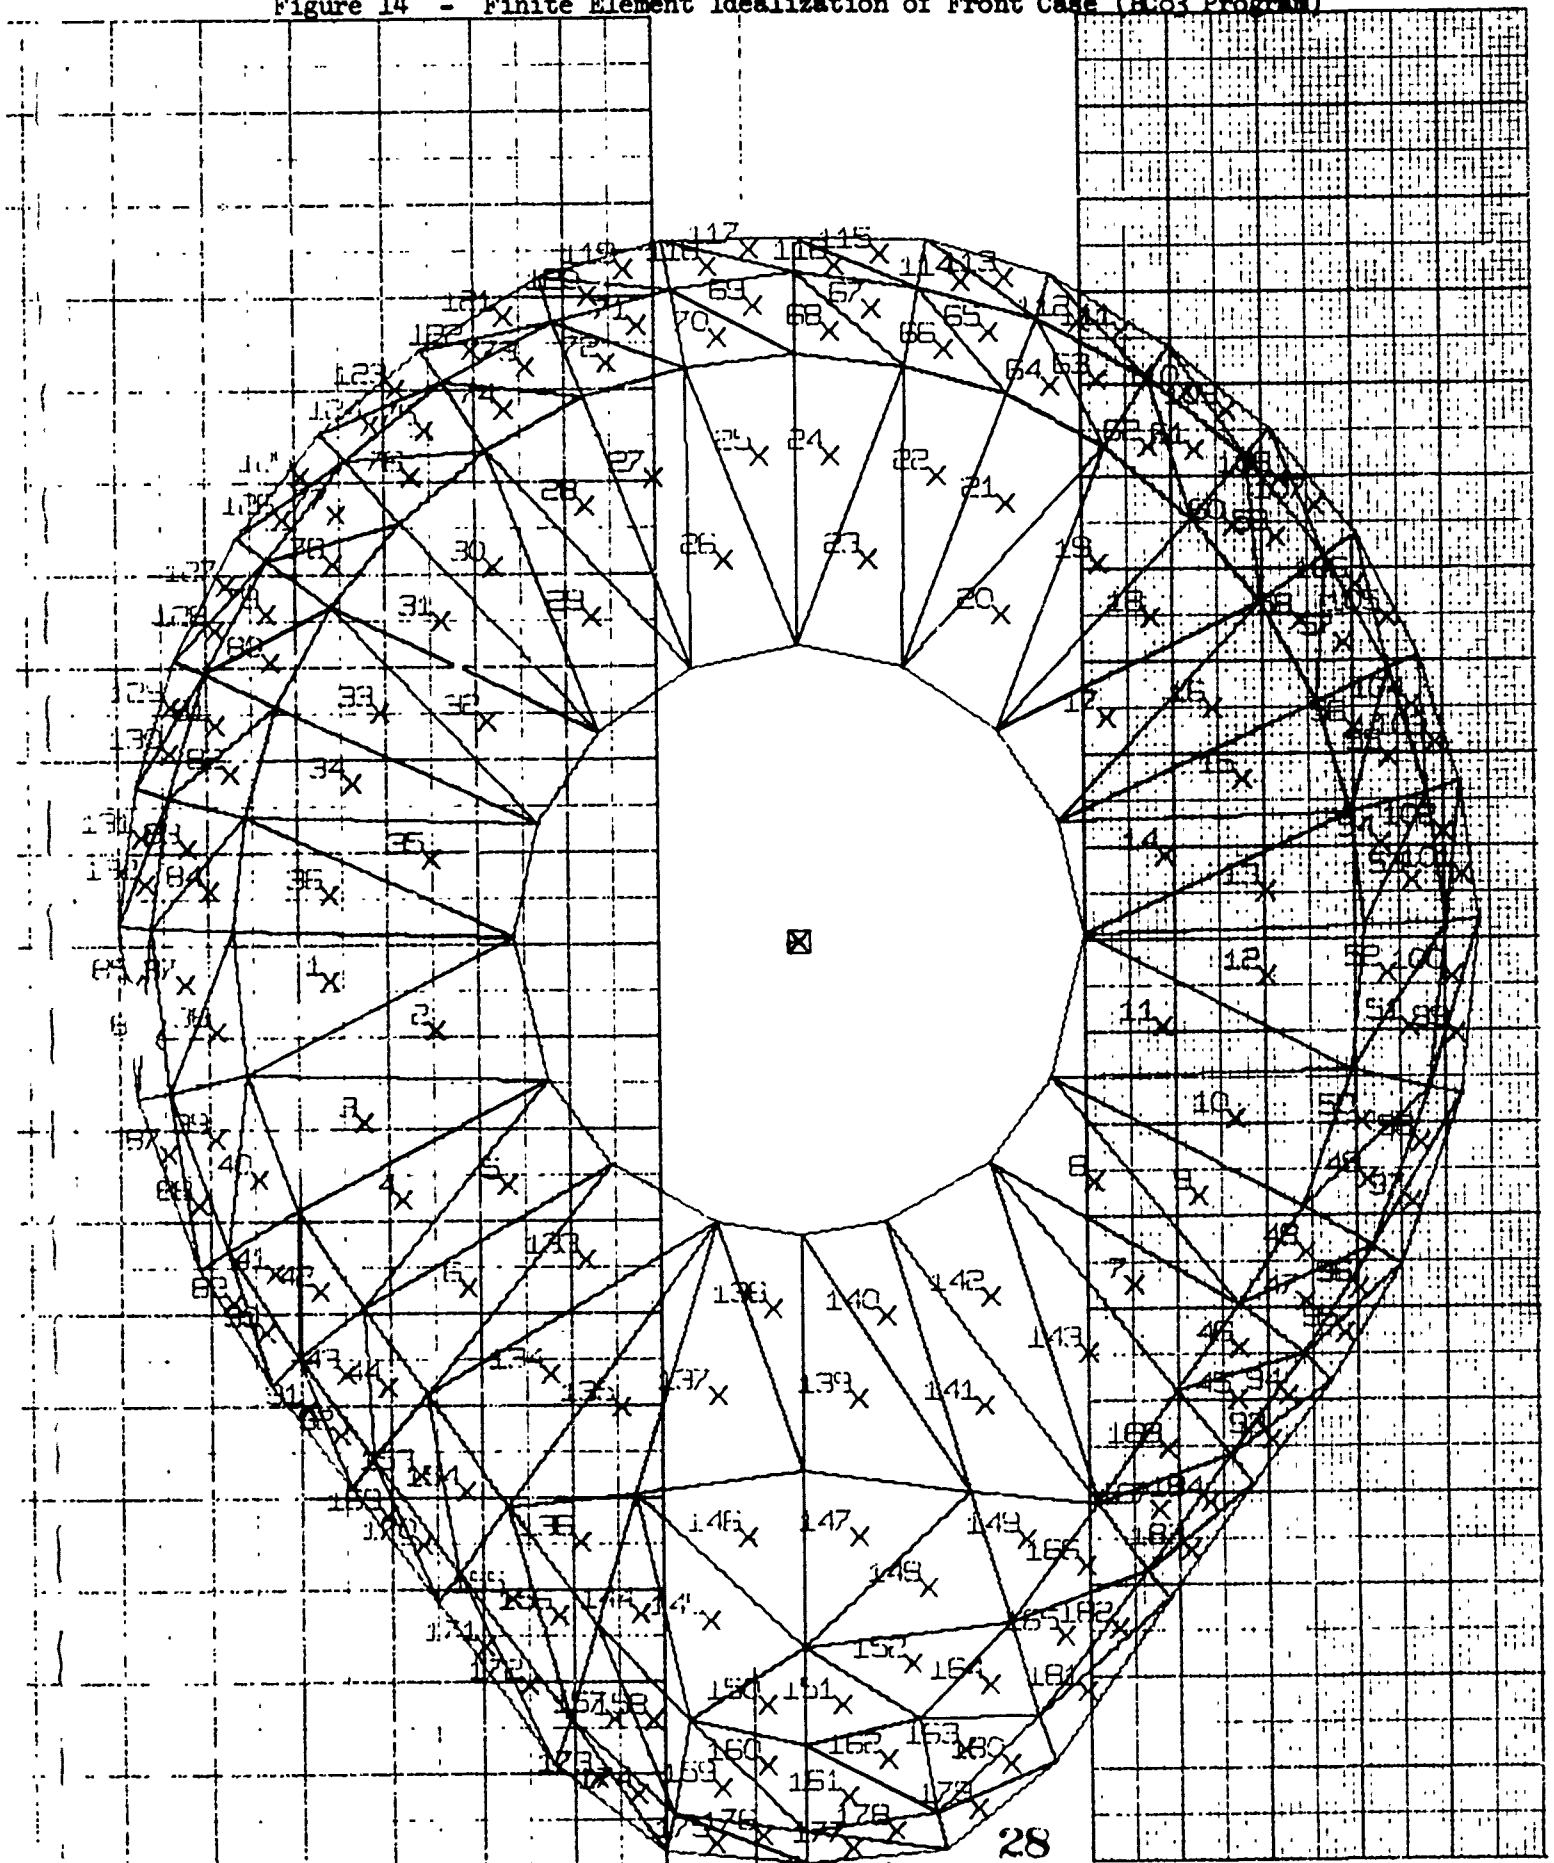
Figure 14 - Finite Element Idealization of Front Case (BC83 Program)

An 1130 computer plot of the front projection of the finite element idealization of the composite case for program BC83 is given in Figure 14.

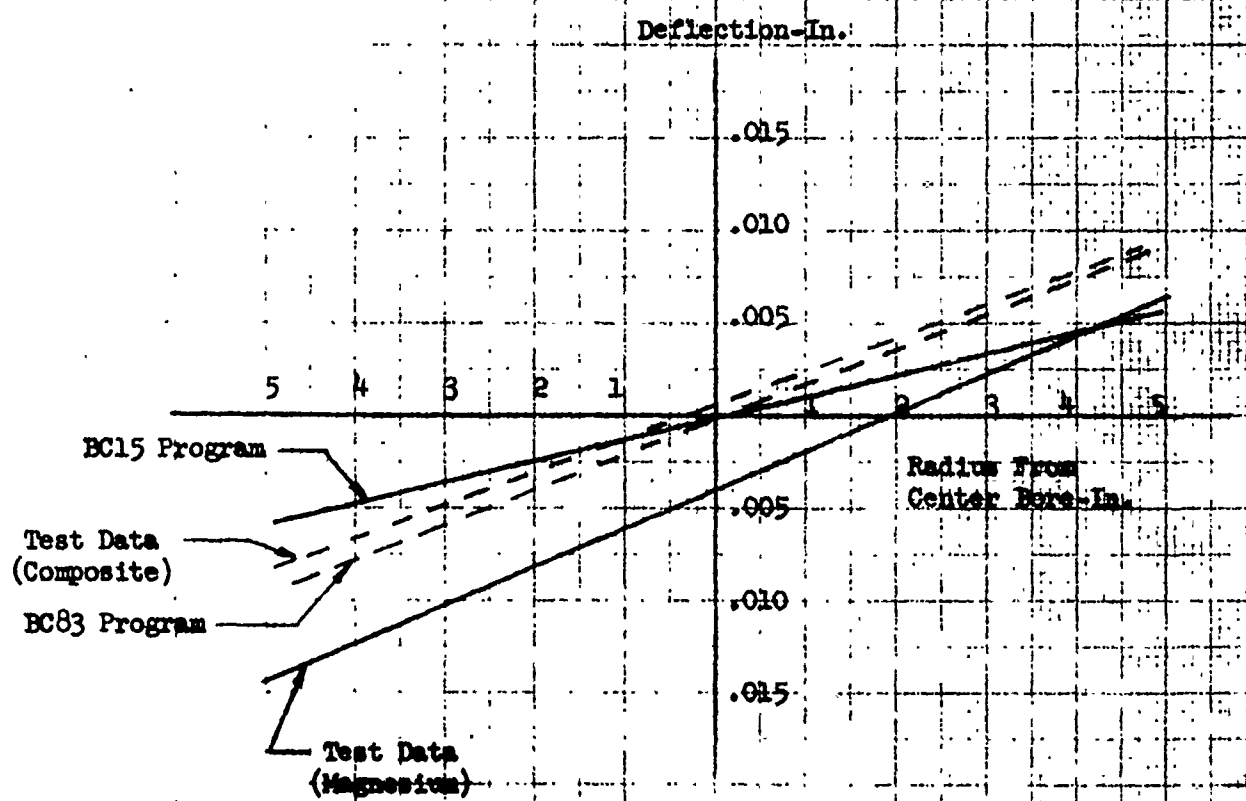
Figure 15 - Comparison of Slope Deflections

A plot of the various front face slopes, computed and measured, is given in Figure 15. The plot shows that the BC83 program results agree with the test data as close as could be expected. All material properties, tolerances and all test variables would have to be known for better correlation.

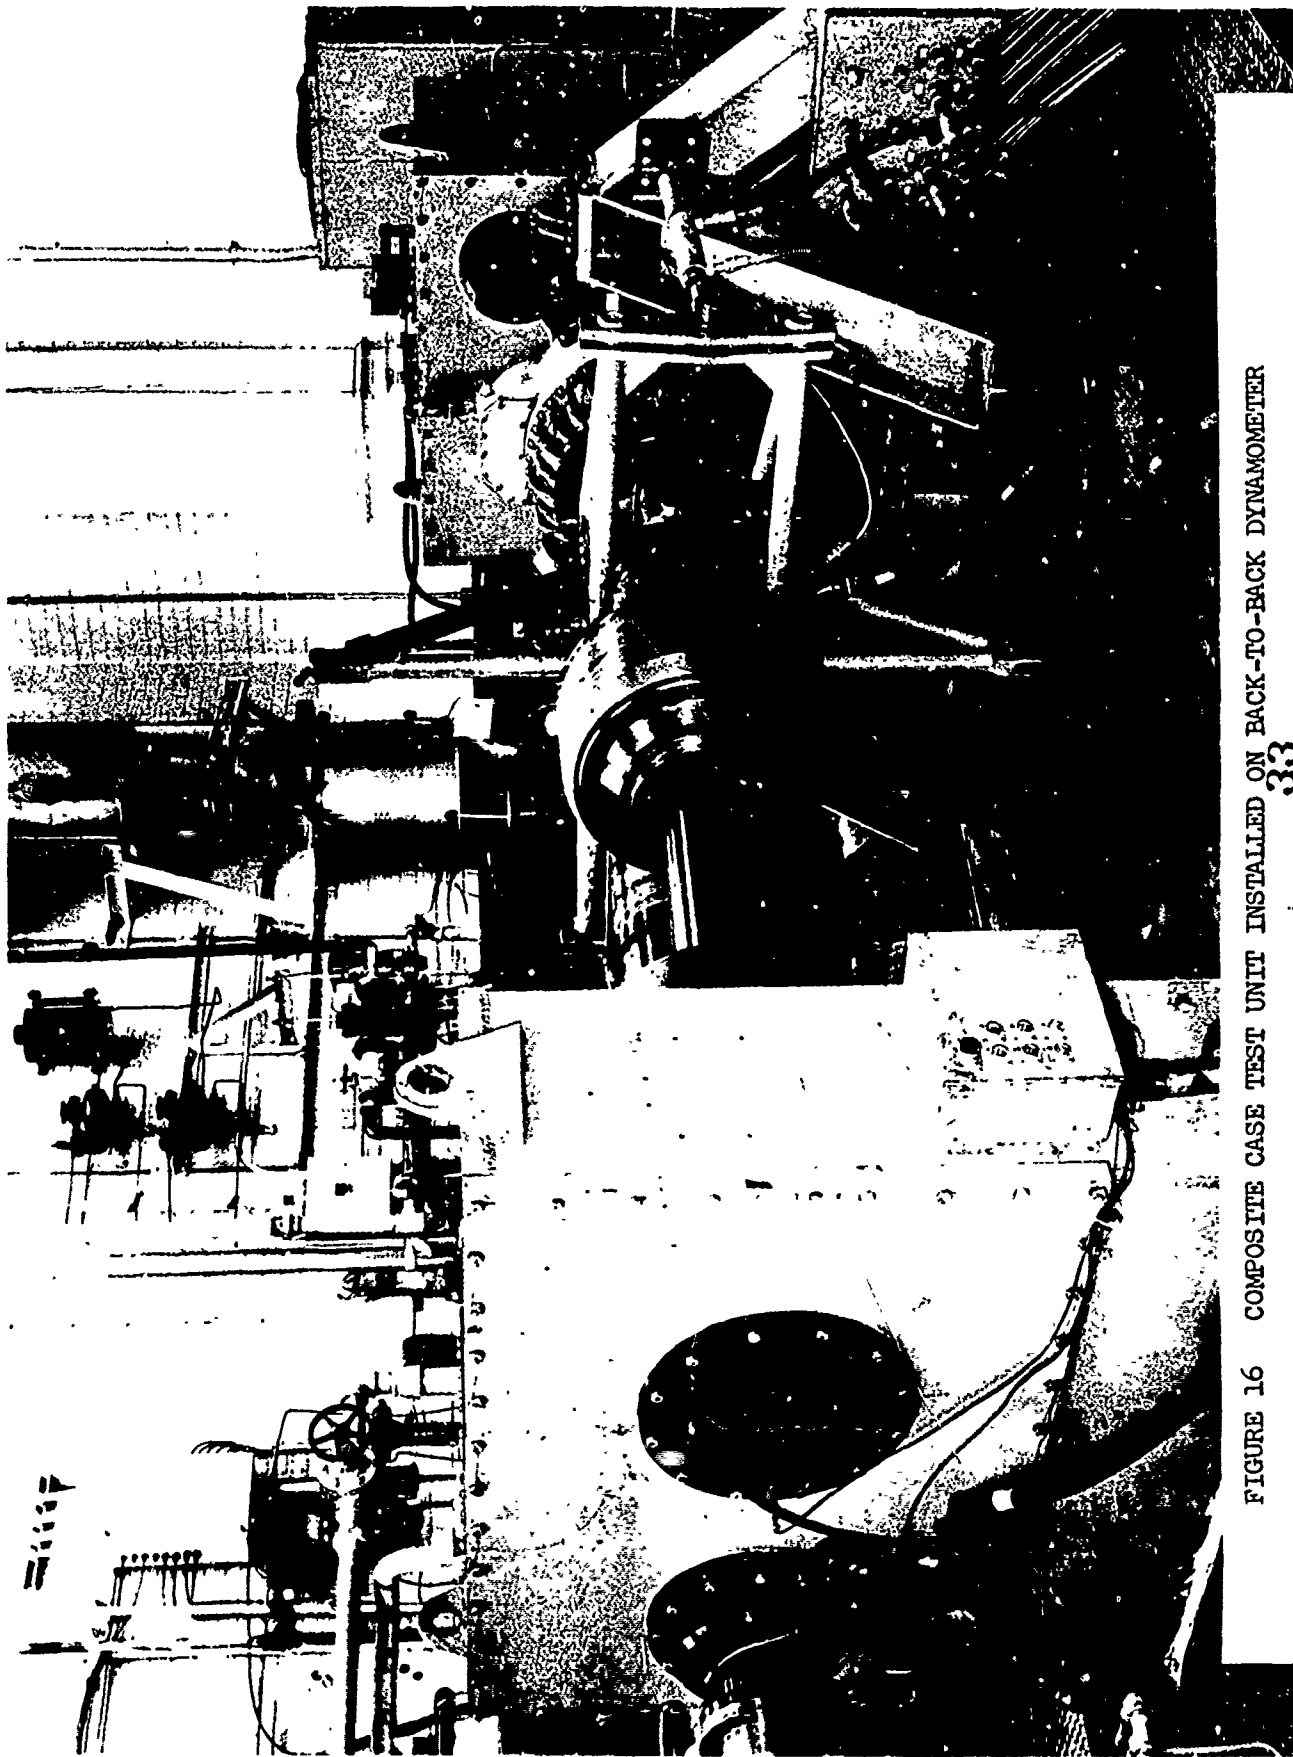
FIGURE 16 COMPOSITE CASE TEST UNIT INSTALLED ON BACK-TO-BACK DYNAMOMETER

A general view of the test set-up showing heavy duty gear boxes, universal joint assembly, moment applying equipment and the test gear box is given by figure 16.
